Rubble-Mound Breakwater Wave-Attenuation and Stability Tests, Burns Waterway Harbor, Indiana

Technical Report CERC-93-15
August 1993

Final report

Prepared for U.S. Army Engineer District, Chicago
Chicago, IL 14207

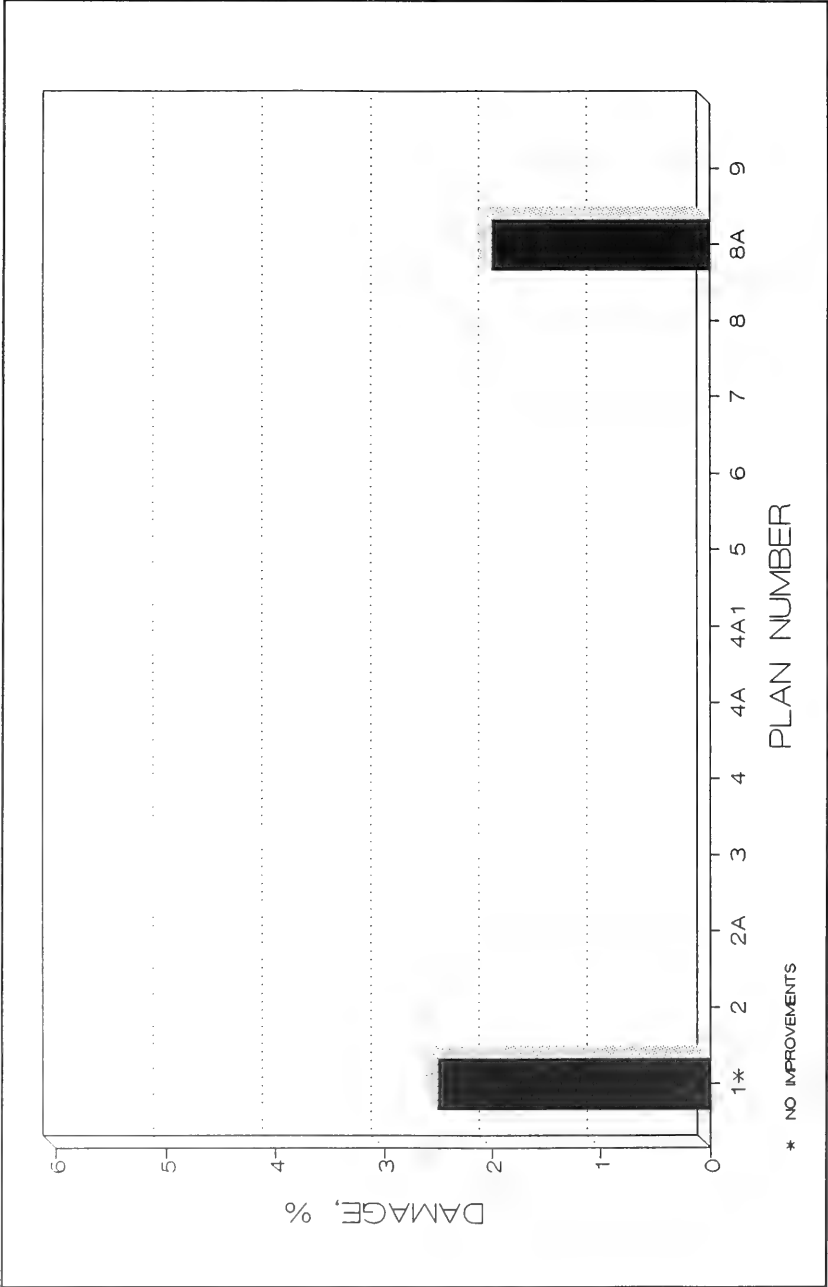
Lakeside and harbor-side damages also are presented in Figures 32 and 33. These data show that all improvement plans, except Plan 8A, which provided no protection on the lakeside, eliminated lakeside damage. Also, all plans reduced harbor-side damage to an acceptable level, i.e., 2 percent or less.

Figure 32. Percent damage incurred by lake-side armor

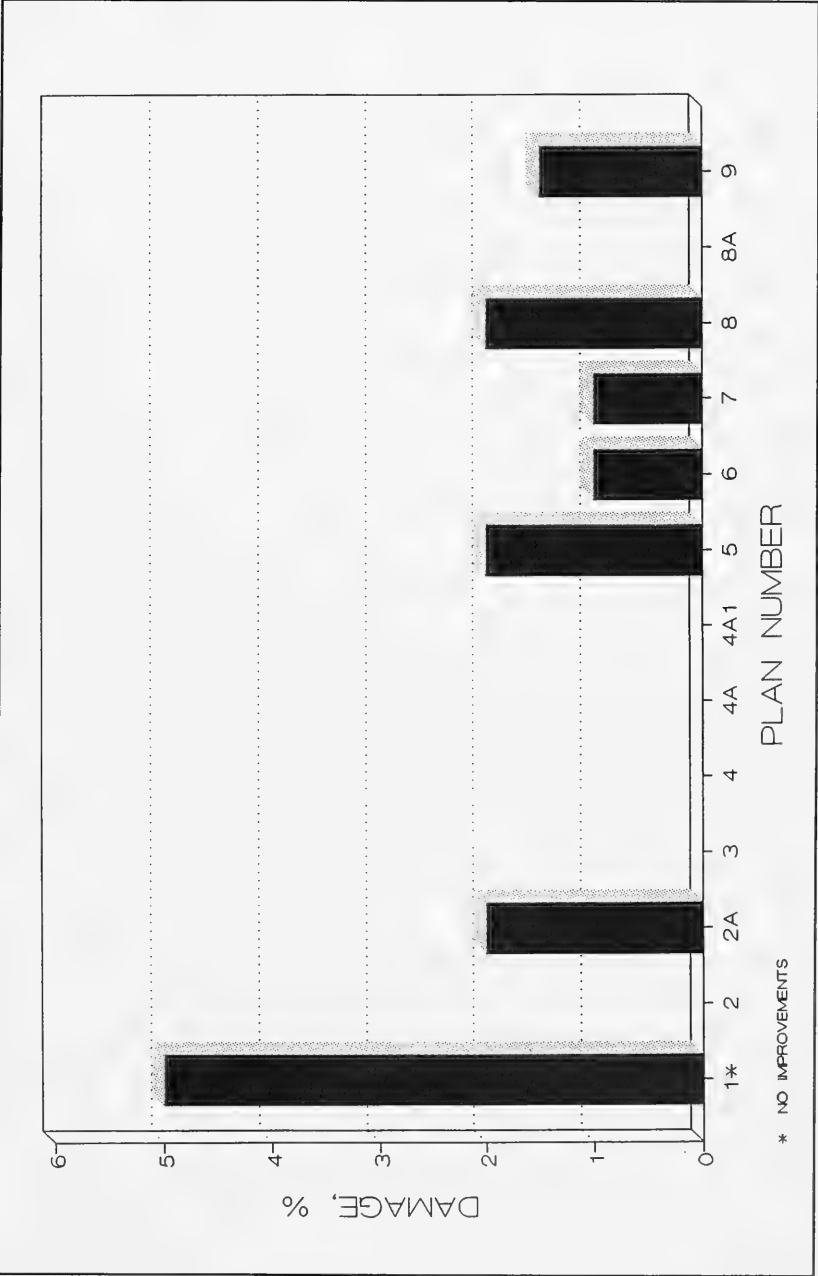
Figure 33. Percent damage incurred by harbor-side armor

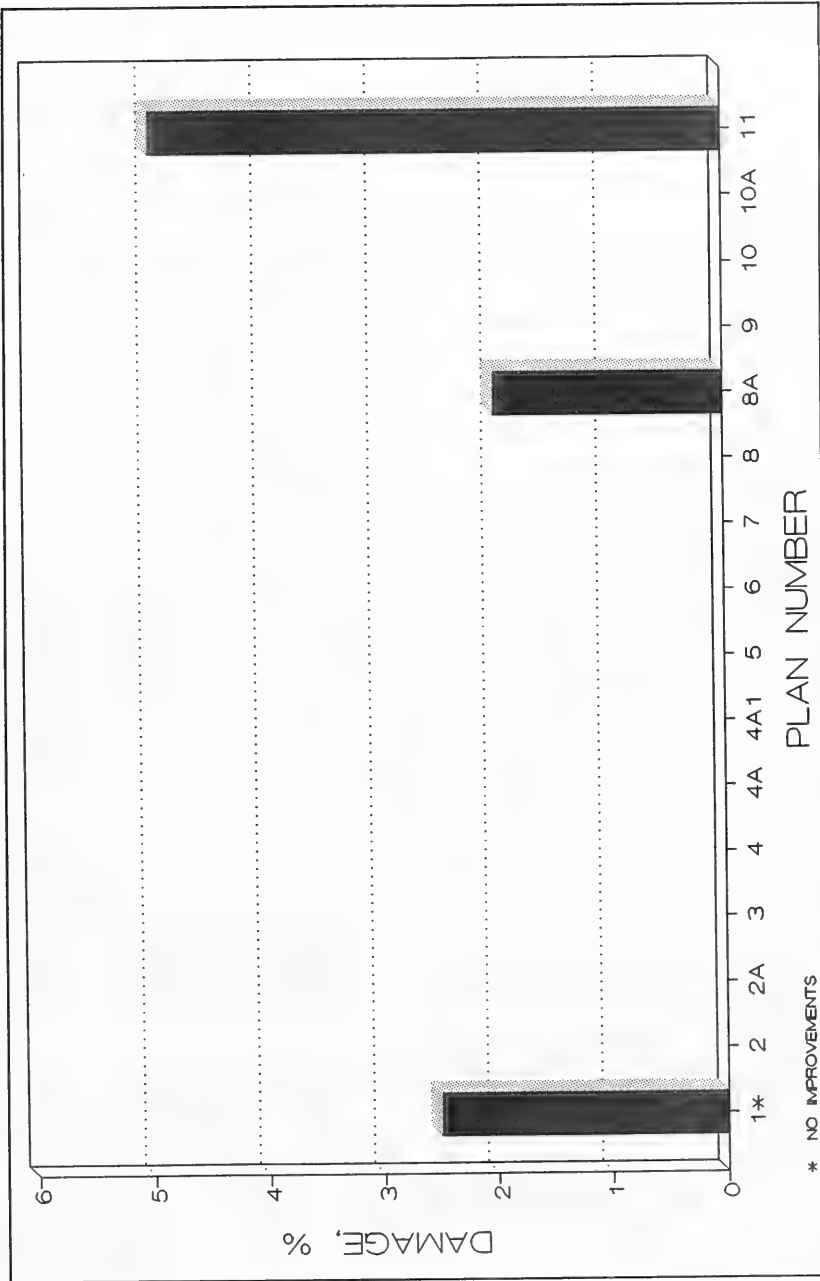
Lakeside and harbor-side damages also are presented in Figures 43 and 44. These data show that all improvement plans, except Plans 8A and 11, which provided no protection on the lakeside, eliminated lakeside damage. All plans, except 10A, reduced harbor-side damage to an acceptable level, i.e., 2 percent or less.

Figure 43. Percent damage incurred by lakeside armor; all plans

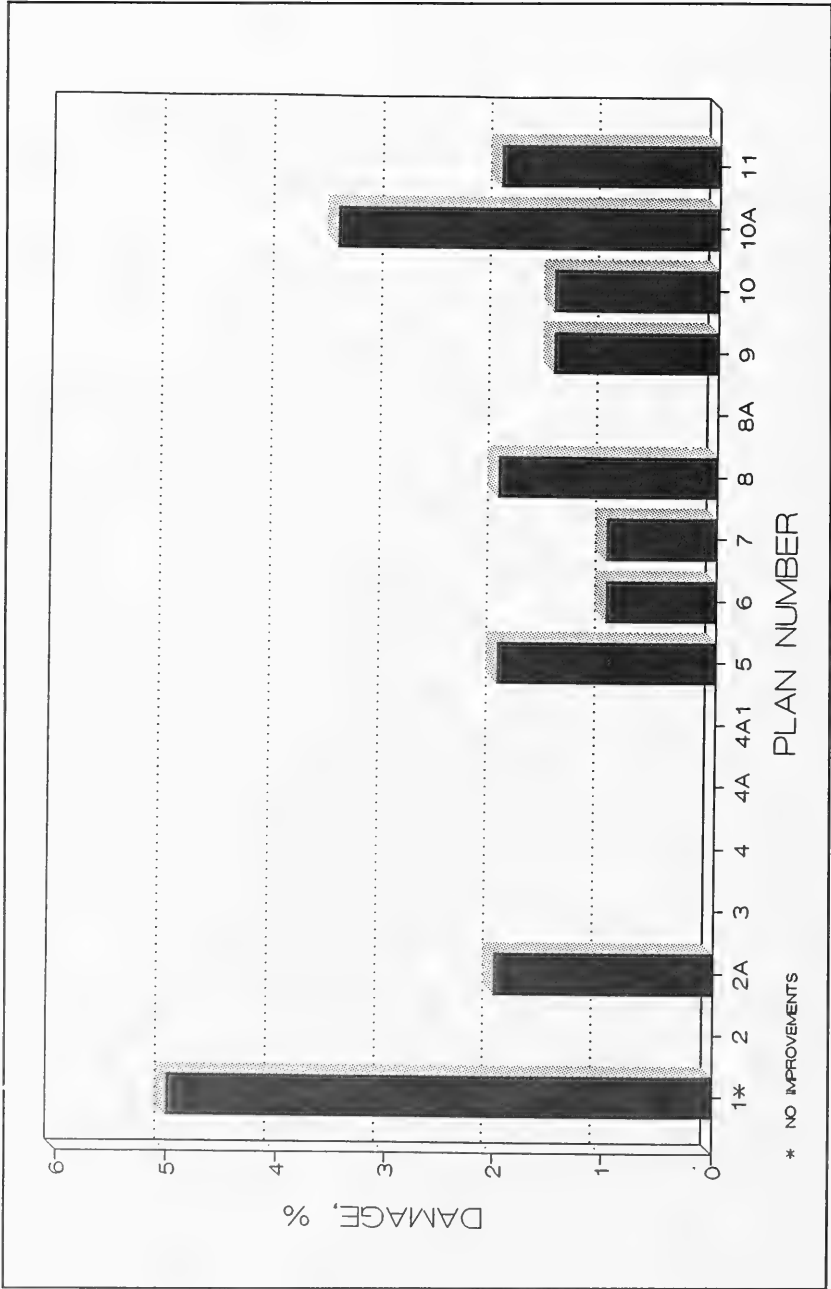
Figure 44. Percent damage incurred by harbor-side armor; all plans

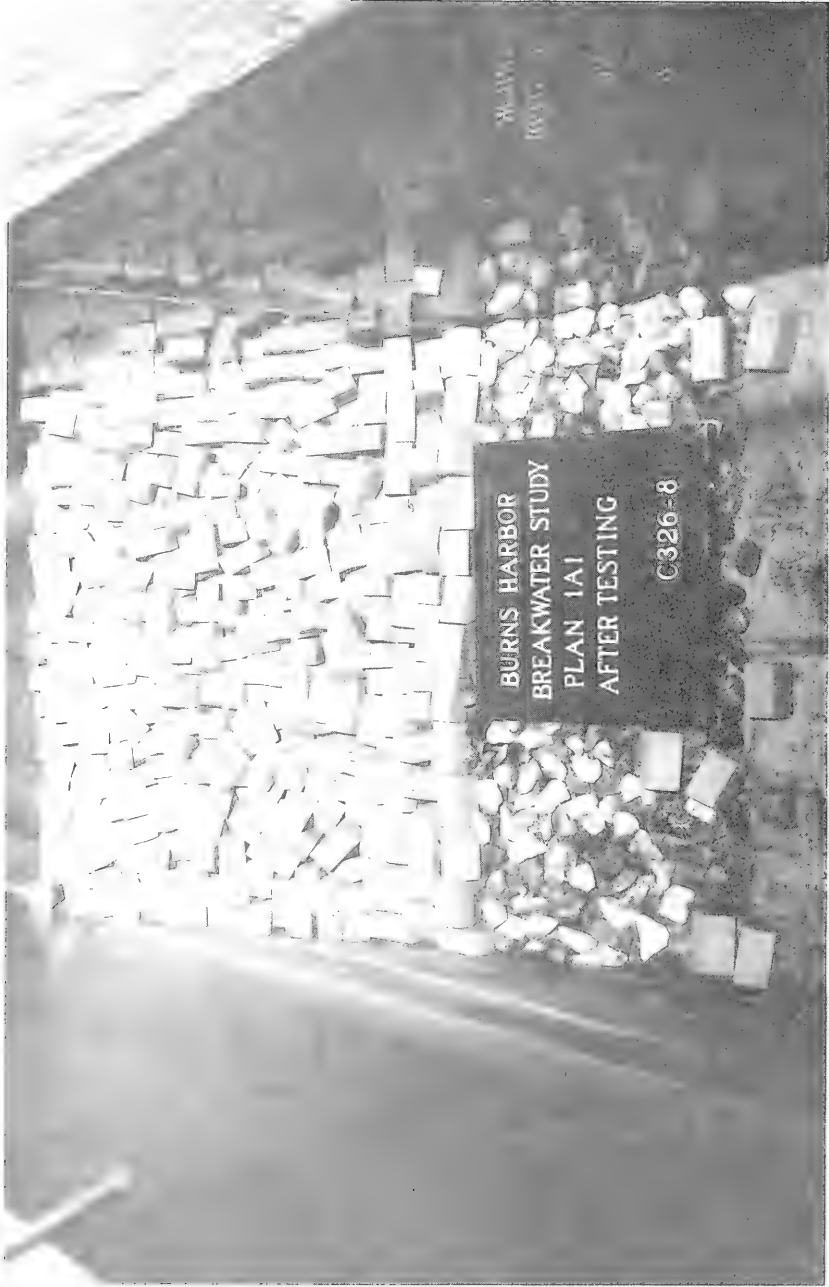
A comparison of the tabulated damages and the after-testing photos (Photos 6 and 7 after the initial test and Photos 8 and 9 after the repeat test) show the structure exhibited a higher level of movement in the repeat test. Results of this type are not necessarily unusual and generally reflect random differences in building that occur from one model structure to another and from one section to another in the prototype breakwater. Model damage patterns appear consistent with the prototype, with most of the damage occurring on the harbor side.

Photo 6. Lakeside view of Plan 1A1 after the initial stability test

Photo 7. Harbor-side view of Plan 1A1 after the initial stability test

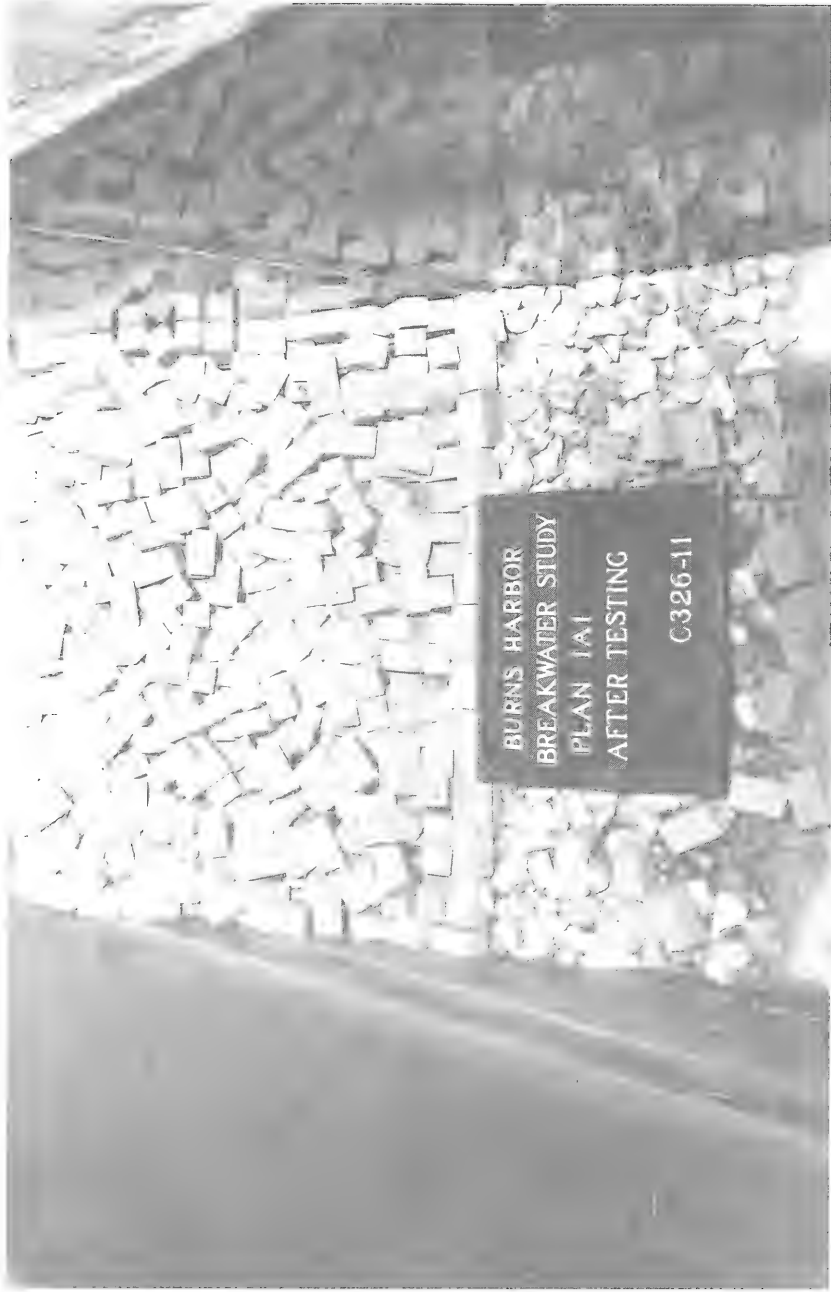
Photo 8. Lakeside view of Plan 1A1 after the repeat stability test

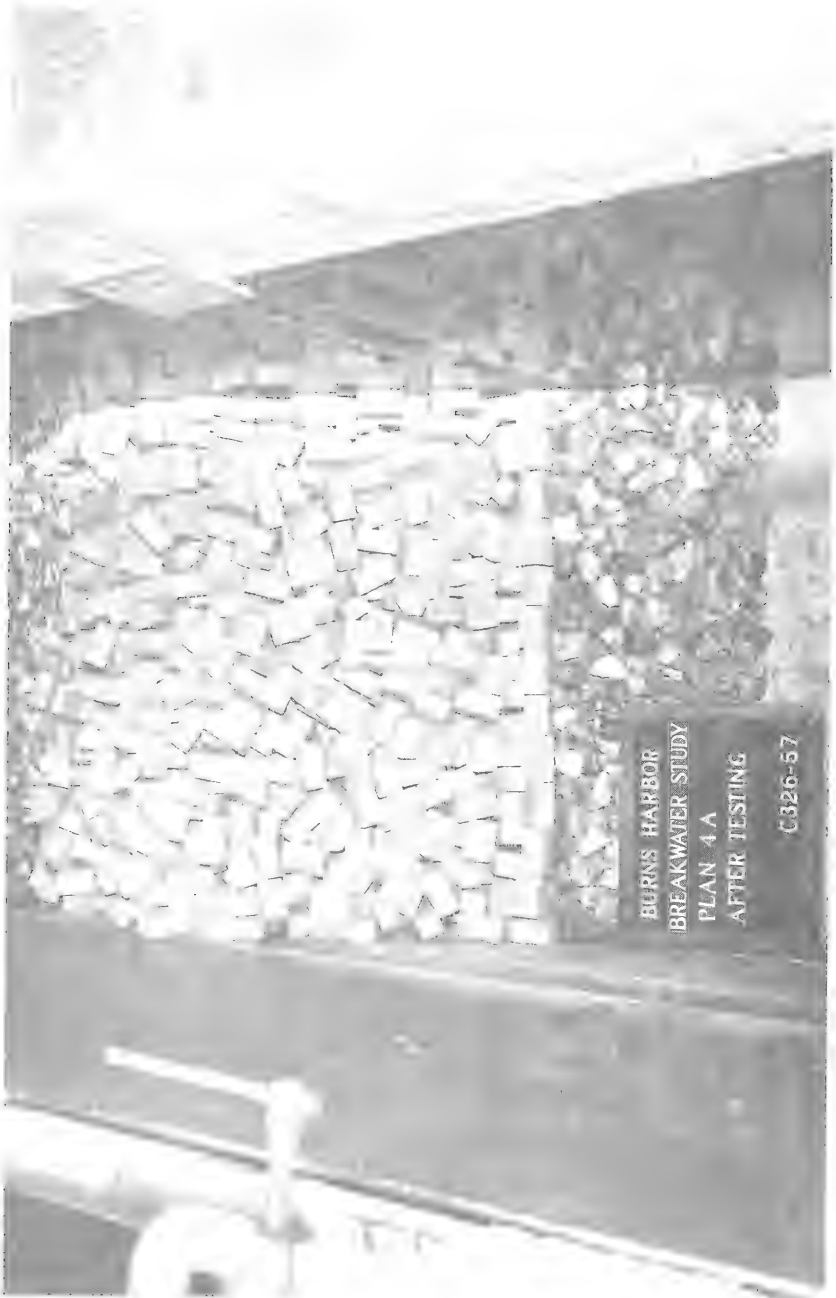
BURNS HARBOR
BREAKWATER STUDY
PLAN 4A
AFTER TESTING
C326-57

As shown above, Plan 4A showed slightly improved transmission performance, relative to Plan 4. The existing breakwater again was completely stable (Photos 30 and 31). The reef experienced some damage (Photo 32) with stone from the lakeward edge of the crown being displaced downslope.

Photo 30. Lakeside view of Plan 4A (existing structure) after wave attack

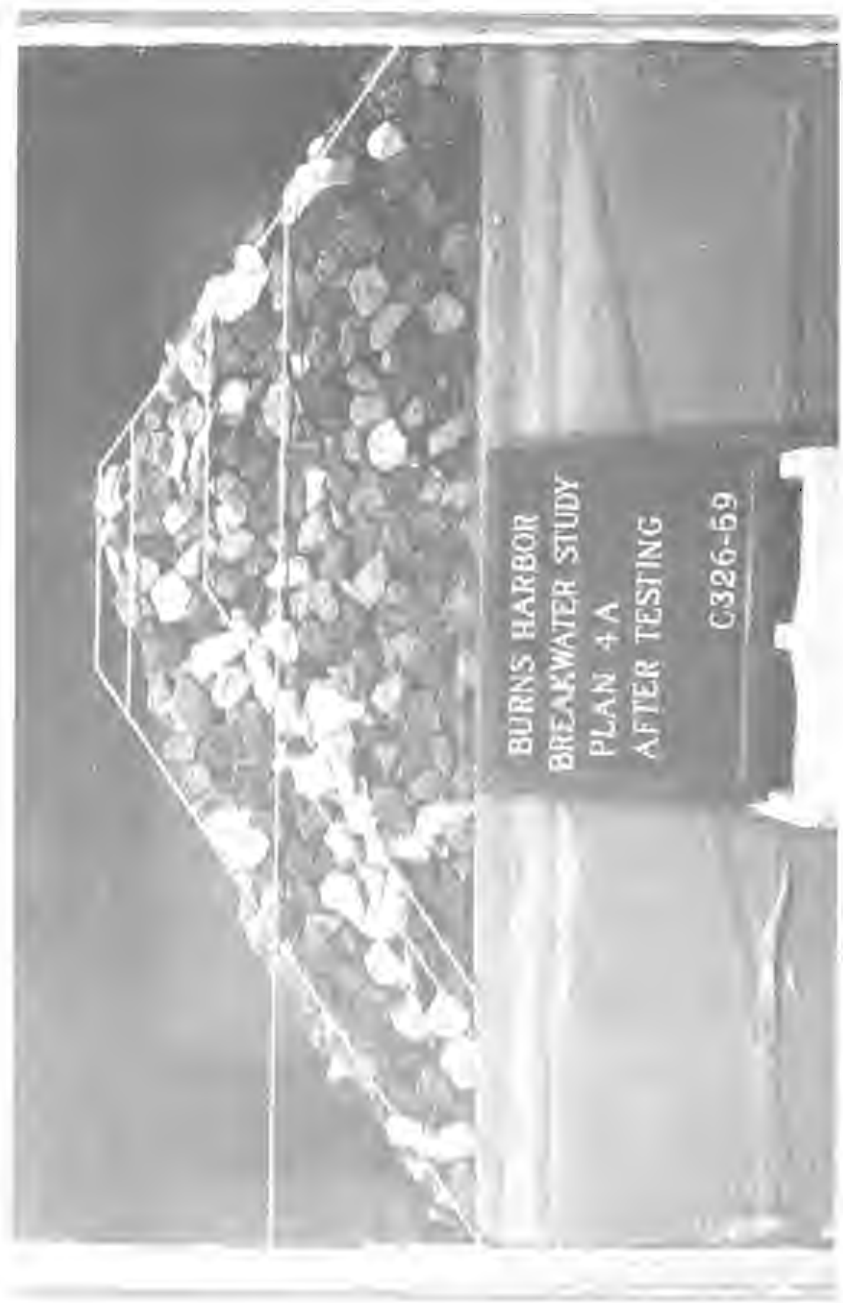
Photo 32. End view of Plan 4A after wave attack

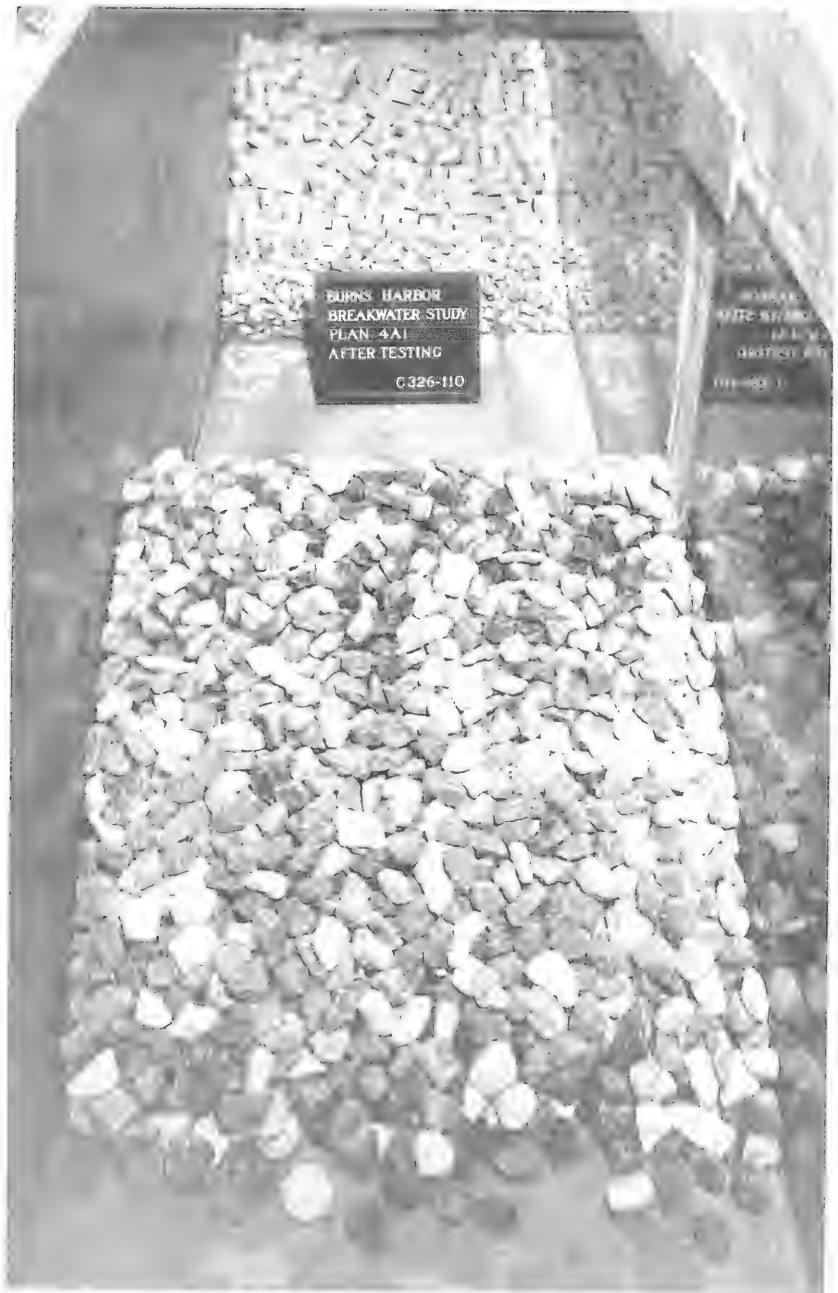
Plan 4A1 generally produced similar but slightly reduced transmitted heights relative to Plan 4A (Figures 13 and 14). Also similar to Plan 4A, the reef experienced some damage with stone from the lakeward edge of the crown being displaced downslope. The existing breakwater was completely stable (Photos 34 and 35).

Photo 34. Lakeside view of Plan 4A1 after wave attack

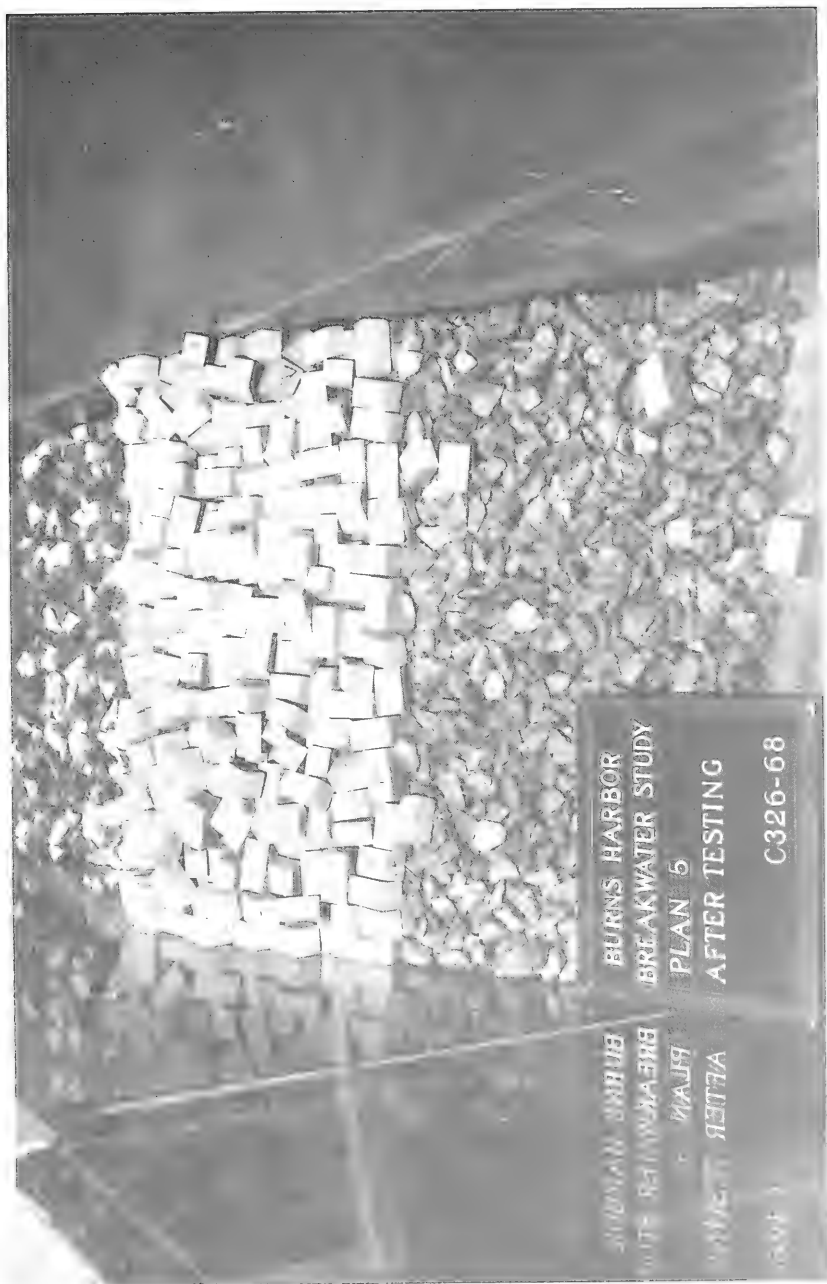
BURNS HARBOR
BREAKWATER STUDY
PLAN 5
AFTER TESTING
C326-68

Stability of the existing breakwater was improved relative to base conditions (Photo 37); however, five armor stones were displaced from the harbor side.

Photo 37. Harbor-side view of Plan 5 after wave attack

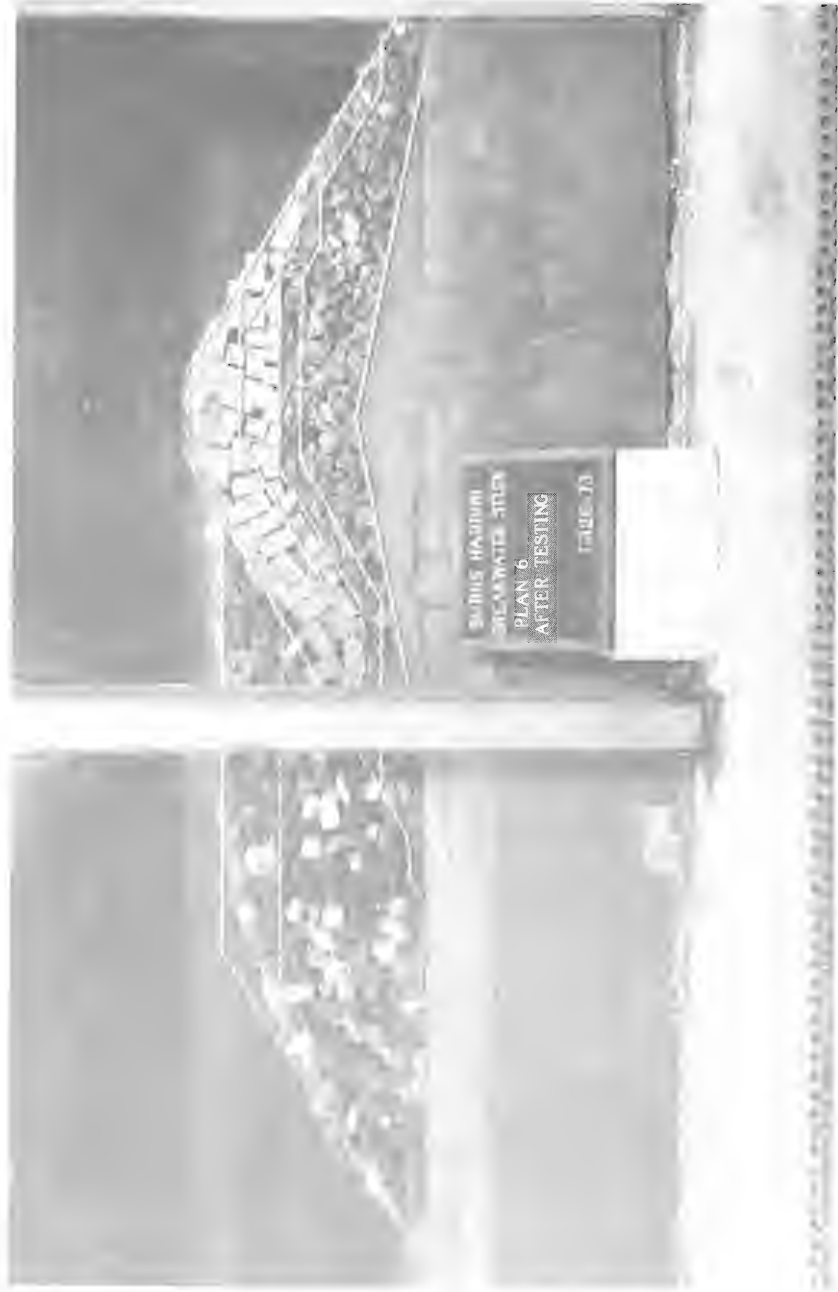
Photos 40-42 show the structure after wave attack. Some reshaping of the berm occurred near the water surface as a significant number of the 5-ton stones were moved under wave attack. However, the existing structure was stable, with only one harbor-side stone being displaced. Based on observed movement, 5-ton stone appears to be only minimally adequate for the berm stone if the crown is brought to the water surface.

Photo 40. End view of Plan 6 after wave attack

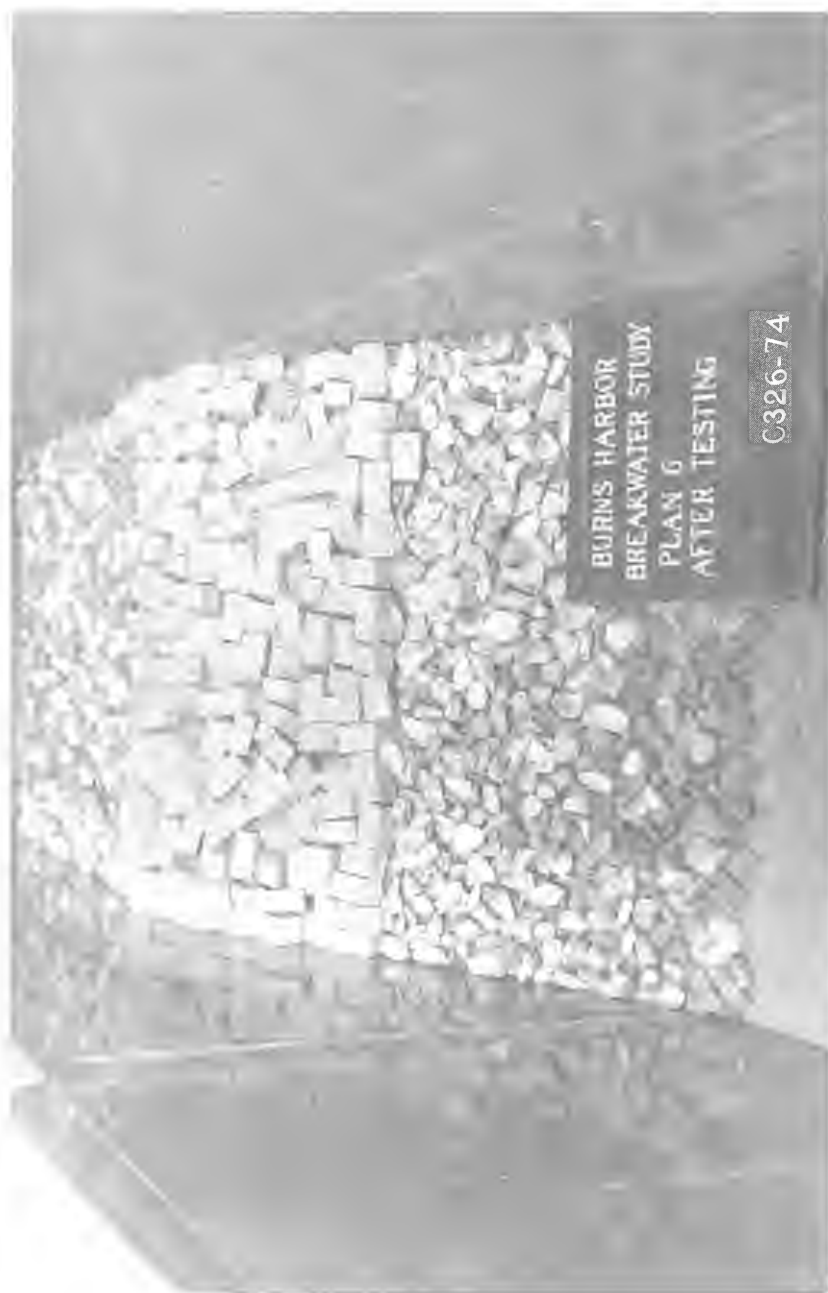
Photo 42. Harbor-side view of Plan 6 after wave attack

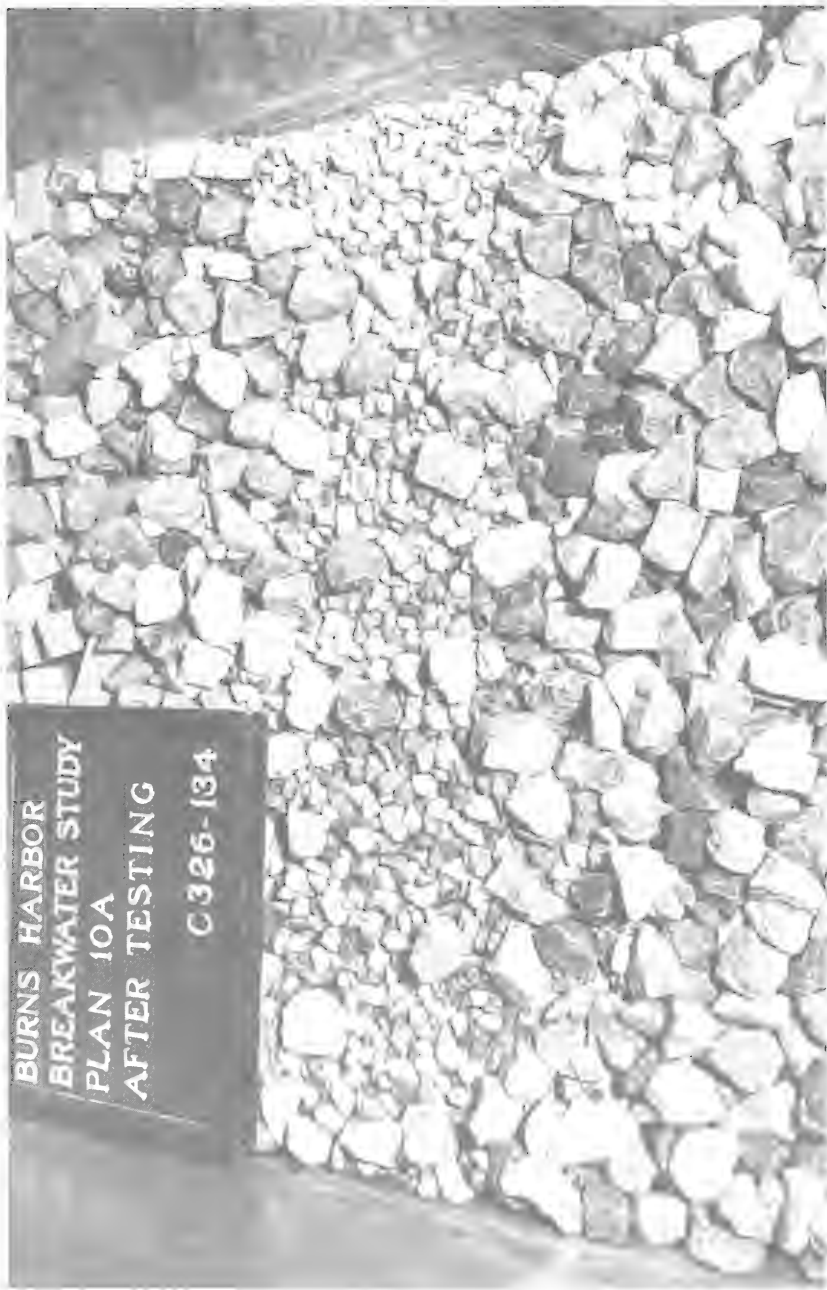
Photo 66. Close-up view of damage incurred by 5-ton stone in the vicinity of the swl
